Interagency Report USGS - 247

THE APPLICABILITY OF REMOTE SENSING TO THE DETECTION,  
IDENTIFICATION, AND MONITORING OF POWER  
TRANSMISSION RIGHT-OF-WAYS WITHIN  
SELECTED AREAS OF THE TVA REGION

John B. Rehder  
Department of Geography  
University of Tennessee

May 1972

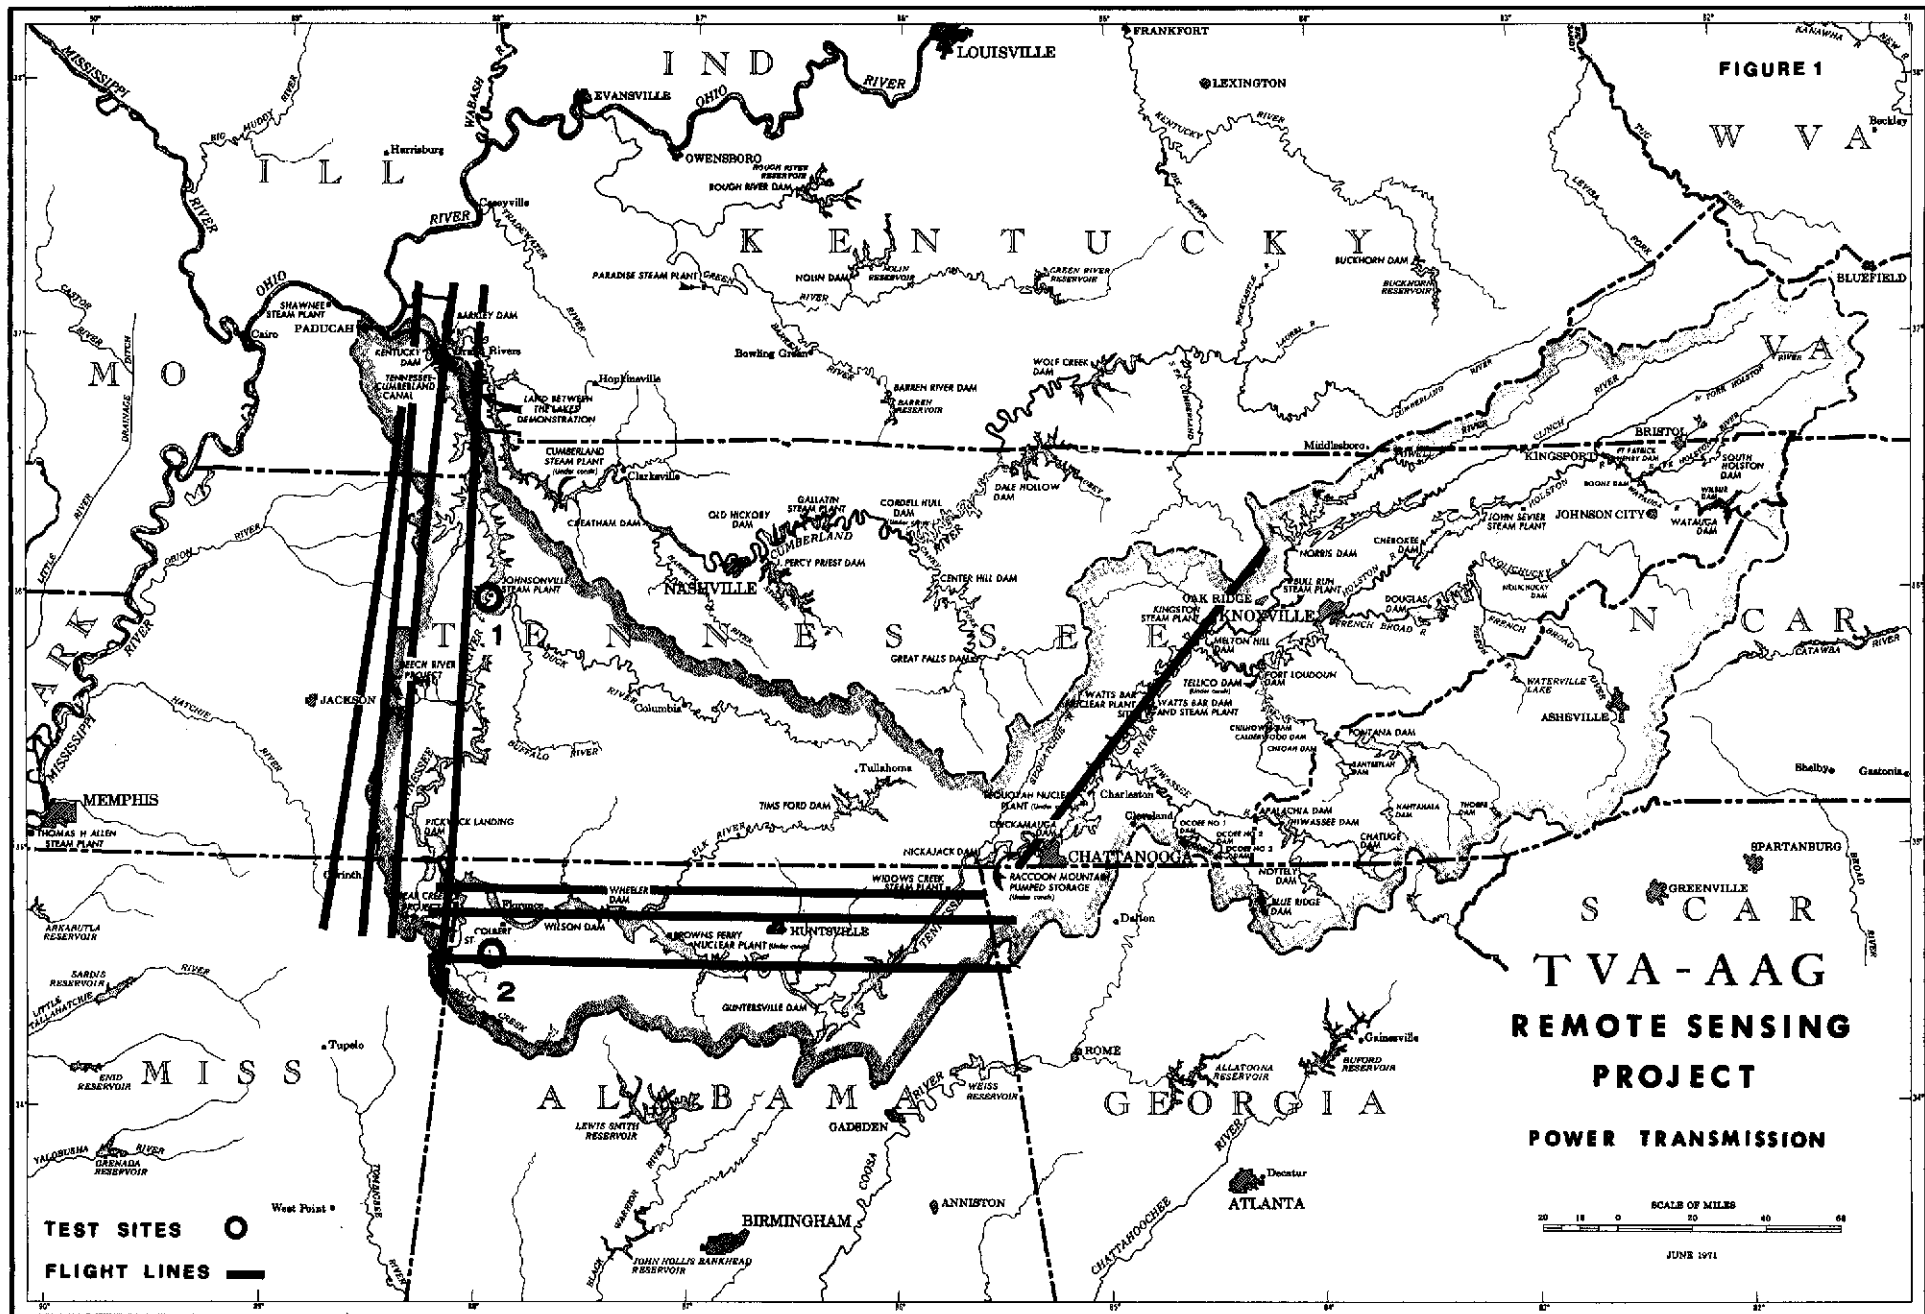
The initial procedure for this interpretive phase was to examine the entire coverage of all flight lines of the 9" x 9" color Ektachrome imagery (scale 1:120,000). Each frame was analyzed for the presence of power transmission right-of-ways and power production sites. Each visible transmission right-of-way was counted, then more closely scrutinized with magnification for the detection of small, low reduction phenomena such as towers or transmission lines. From 211 interpreted image frames which contained power transmission related phenomena two examples were chosen for closer observation and mapping (Figure 1).

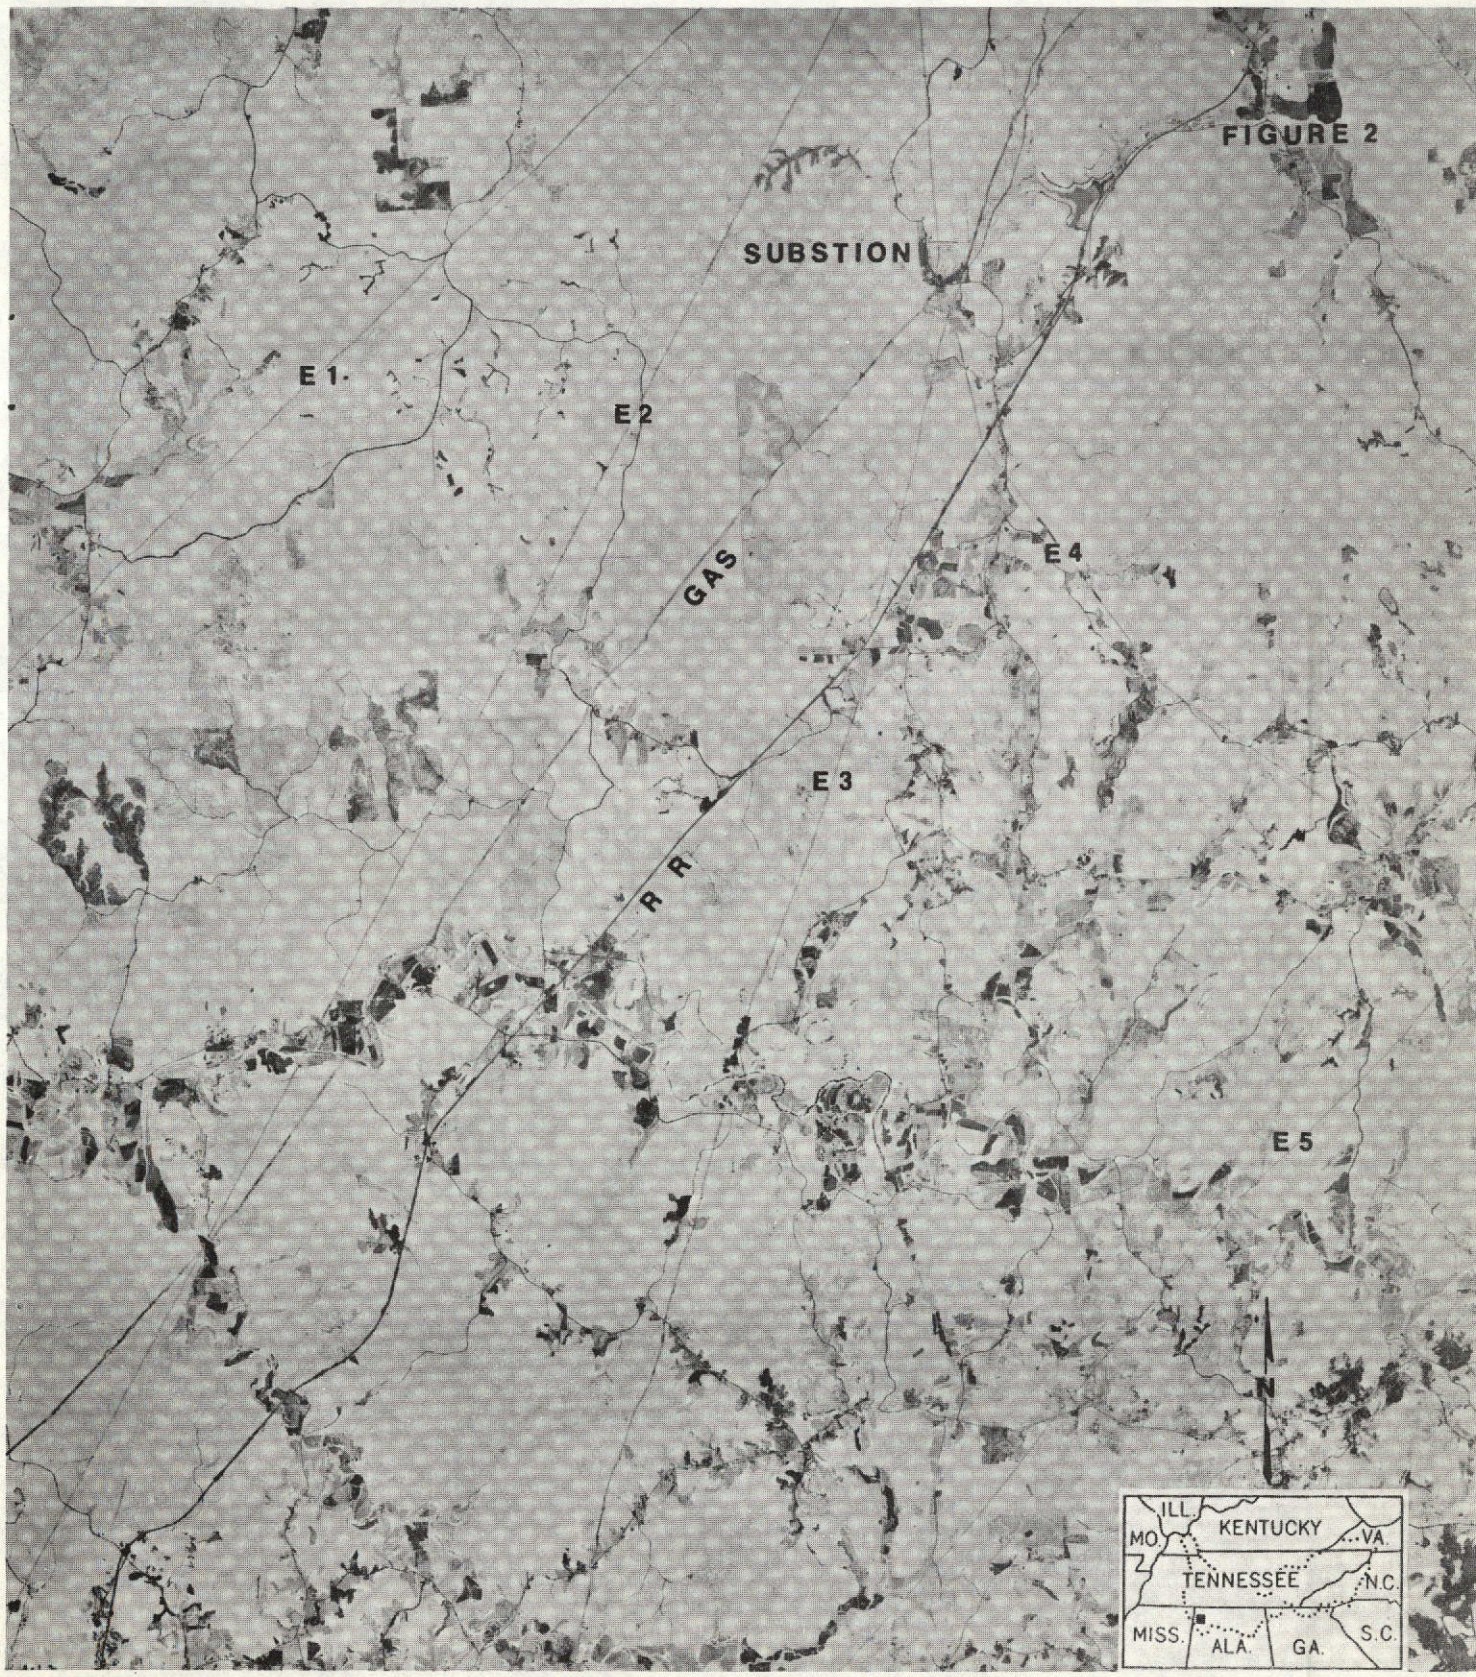
The photograph in figure two best represents the nature of power transmission right-of-ways in terms of their landscape expression. The right-of-ways here labelled E1-5 are located south of the Colbert Steam Plant and northwest of Russellville, Alabama. Within the image are other linear features which could be mistaken for power right-of-ways. The irregularly lineated gas pipeline right-of-way and the railroad in the center of the photograph are cases in point.

Details of the power transmission right-of-ways reveal several distinctive characteristics. Although transmission lines and towers are not visible on this negative print, on the original color transparency, the towers can be seen through the use of magnification. Furthermore, the substation, appearing in the upper right portion of the image, revealed on the original transparency six banks of transformers.

The width of power transmission right-of-ways often indicates the relative amount of kv's being transmitted. Right of ways E-1, E-2, E-3, and E-5 are 100-150 feet wide and, as verified by TVA maps carry 161 kv. Right of way E-4, which is part of an electric cooperative, measures 75-100 feet wide and carries 46 kv.

Standard aerial photographic techniques using a portable light table for illumination and an 8X Agfa Lupe lens, a lighted 4X table mounted magnifier, and a fine scale comparator for magnification and measurements were applied to the interpretive phase of the imagery. Photo maps were made at a 1:1 ratio to the photo scale and thus express the same scale as the imagery, 1:120,000. An attempt was made to photograph several selected frames of the imagery but with little success. However, this led to an experiment in the contact printing of the original color imagery transparencies into reversed black and white prints. The result was a pseudo-negative print which very clearly enhanced the presence of cultural phenomena within vegetated areas and subsequently aided in the detection and presentation of power transmission right-of-ways (Figures 2 and 3).

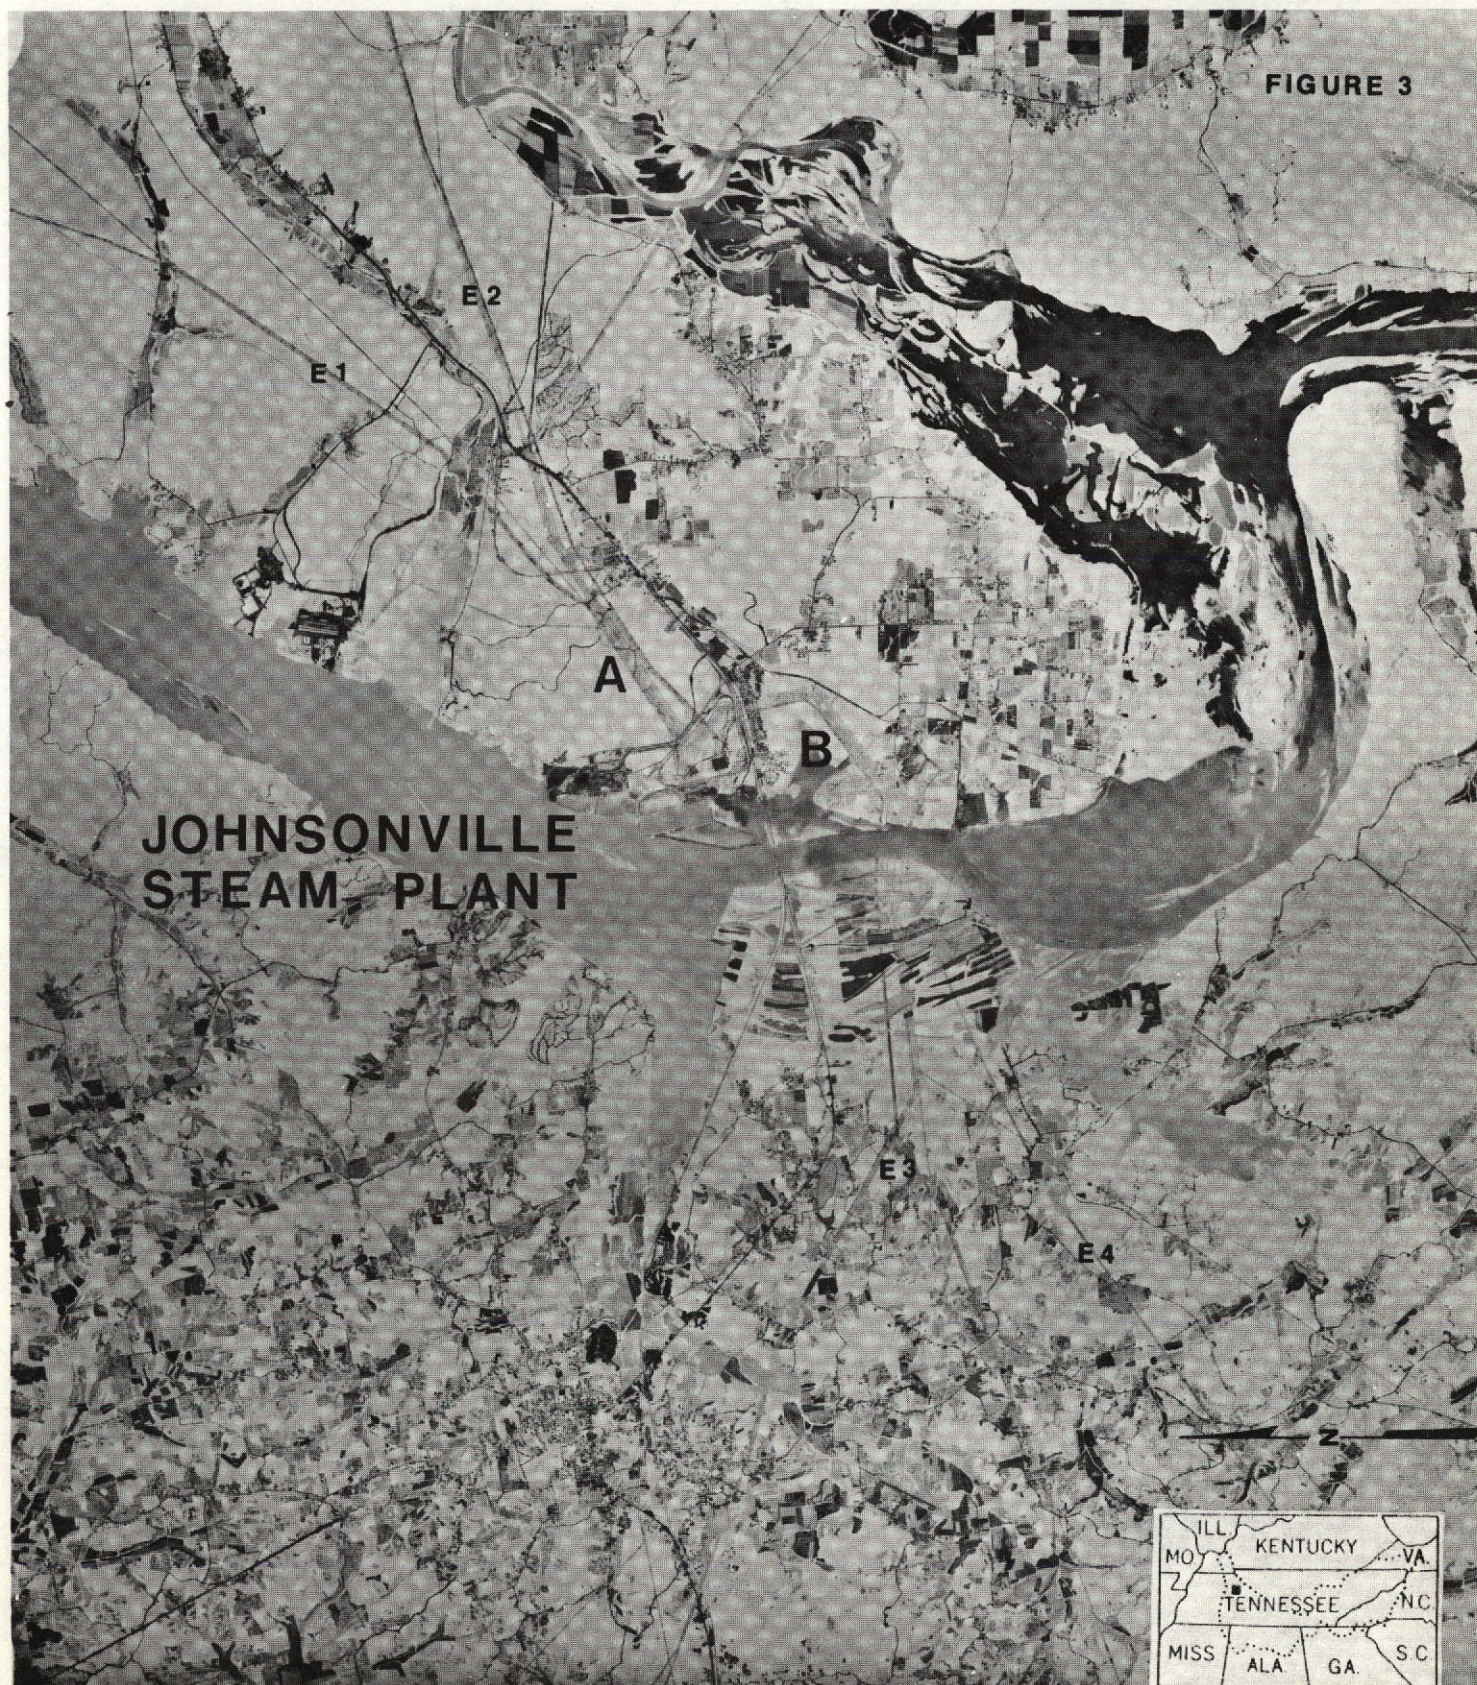
The photograph in figure three represents a power generation site and its related power transmission switchyards, and right-of-ways. The steam plant, located at the center of the photograph, transmits power out on 14 right-of-ways. The larger right-of-ways nearer the east side of the plant transmit power on eight routes that collectively occupy a swath which is 1180 feet wide (A). Among these are two 500 kv routes, one of which serves the Nashville area. The other, newer 500 kv route, is directed toward the Cumberland Steam Plant to the northeast.

Serving the area west of the Tennessee River, six right-of-ways occupy a swath of 850 feet width (B). Within this area are two 500 kv routes which service the Memphis area.

Although transmission lines are not visible here, several of the right-of-ways have visible towers in them. Most noticeably are the tower placements in the upper left portion of the photograph in the new 500 kv right-of-way.

Swath widths for individual right-of-ways vary from 75 to 200 feet. The larger width routes (150-200 feet) which normally carry 500 kv are located at E-1, E-2, and E-3 and E-4. With the exception of the smallest swaths, all others measure 100'-125' wide and are 161 kv transmission routes.
